WABCO	<u>Service Bulletin</u>		PROD GROUP NO	TRI	YEAR	CUR NO
			300			
		DATE 2/08/10	DOC CODE	SHEET 1 OF 1		
PRODUCT IDENTIFICATION 914 005 061 0	PRODUCT NAME Land Rover Piston Pump ERR3539			ORDER NO.		
DISTRIBUTION : File Copy. ----- ----- ----- -----			FOR INFORMATION :

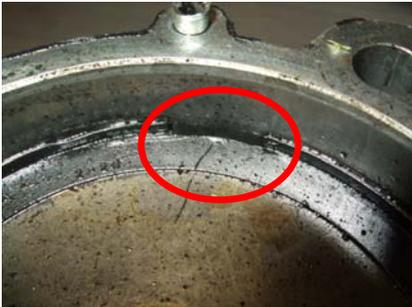
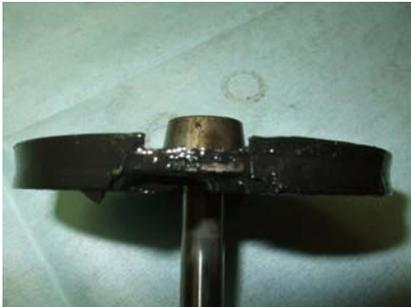
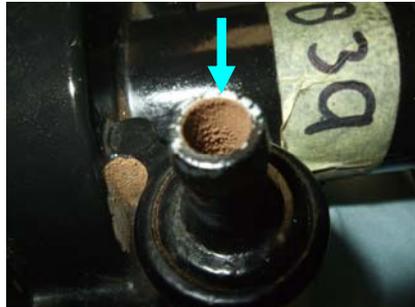
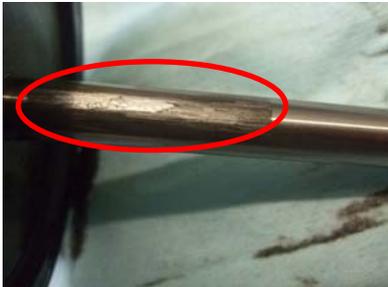
To minimise the possibility of failure due to contamination and oil starvation there are a number of actions that can be taken.

- 1 Ensure that the oil jet that is pointed towards the cam follower on the pump works correctly.
- 2 Before fitment of the new pump ensure that the engine is clean and that a new oil filter has been fitted. It is recommended that flushing oil is used to clean the engine.
- 3 Check the brake booster circuit to make sure that the pipe from the vacuum pump to the booster is intact and there are no issues with the booster, it is possible to suck contamination into the pump via the booster.
